## WATER RESOURCES

### **Stream Description**

## Water Quality Assessment

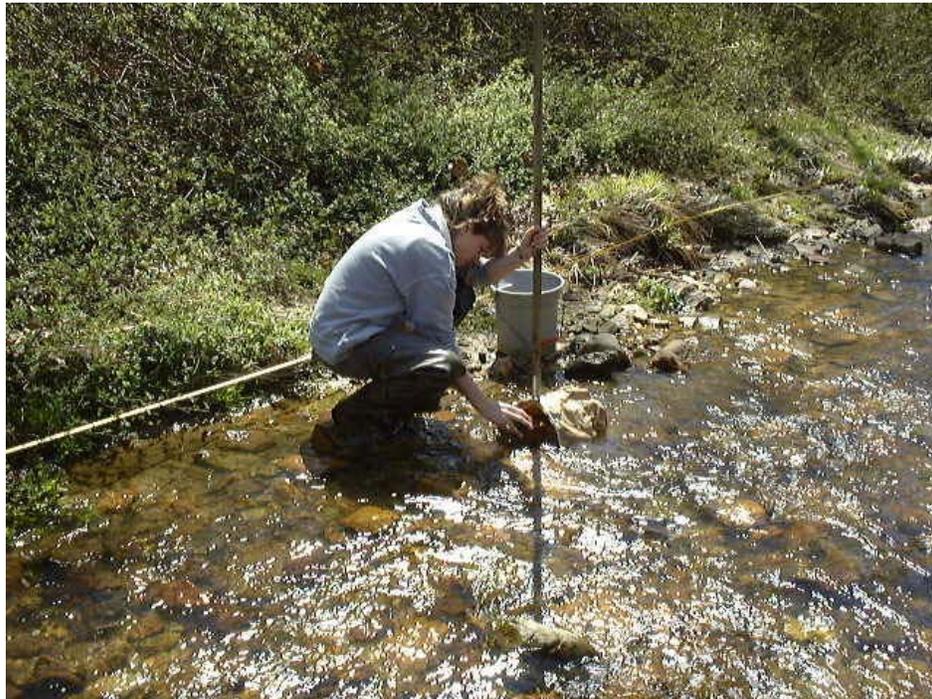
This photograph shows Susan Laubscher of the Penn State Cooperative Wetlands Center collecting "bugs" in Pine Creek near Bertolet Mill Road. Because of its EV ranking, Pine Creek has been the subject of continuing water quality assessments over the years.

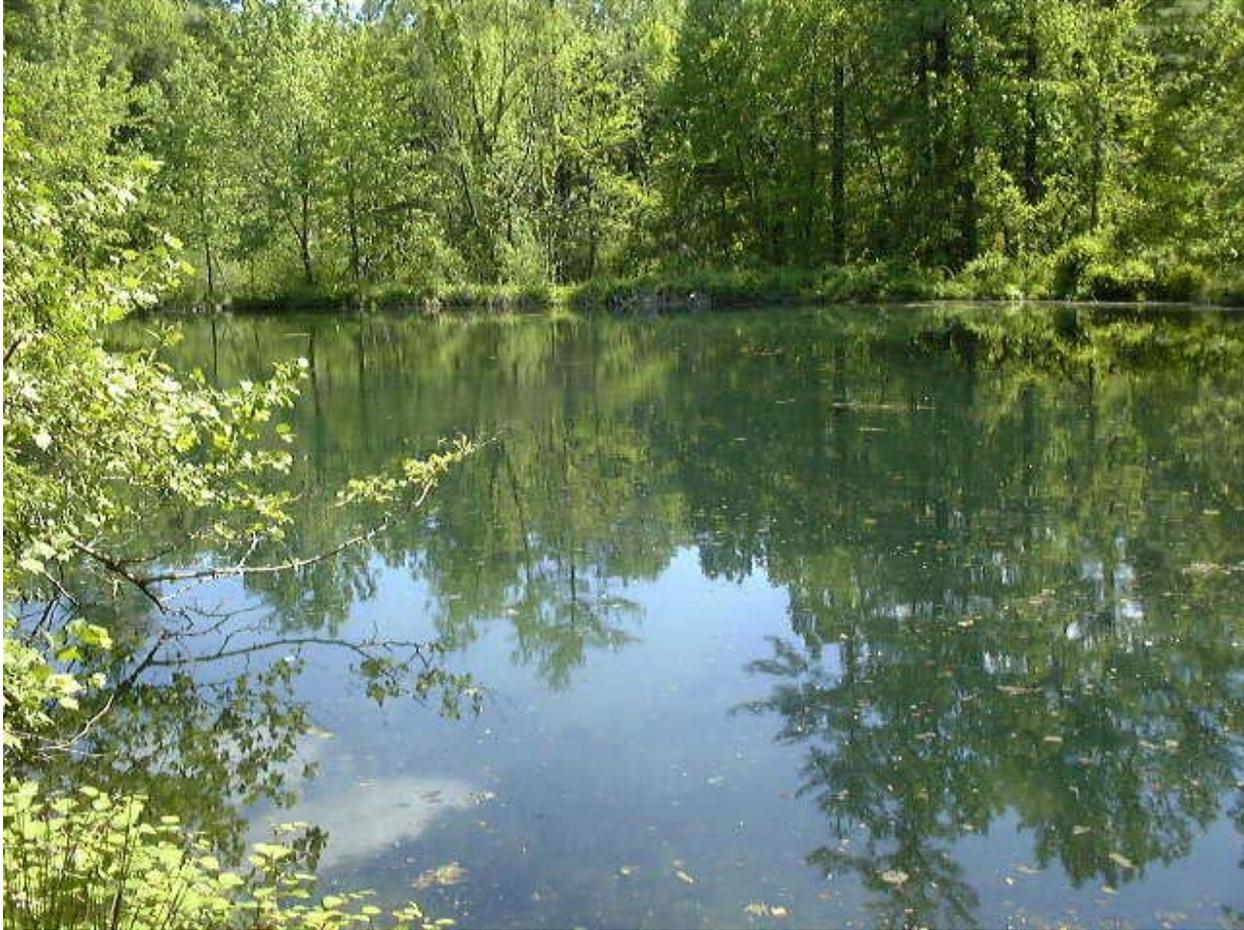
This map illustrates the approximate location of most ponds in the watershed. The Lobachsville Trout Hatchery pond (pictured on the next page) is shown at the lower left and appears to be outside the watershed boundary.

This section of the watershed was not included in the PA GIS small watersheds coverage, and therefore is not mapped in this Plan, although the spring at this source is an important contributor to Pine Creek and the EV wetlands at this site.

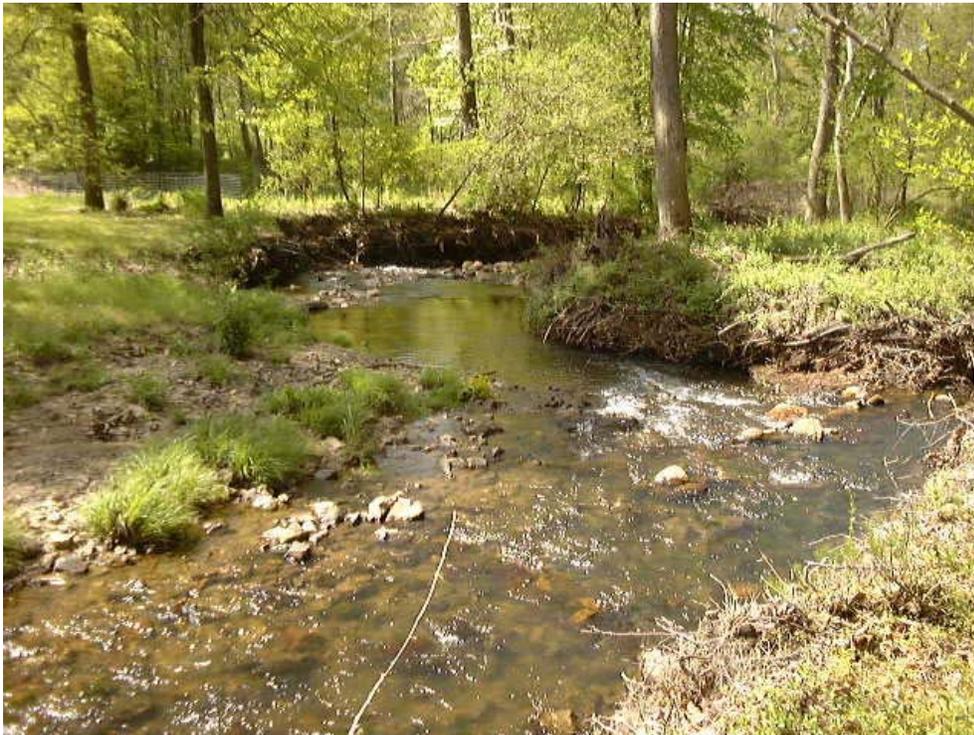
The summer of 2001 had several severe storm events, which not only caused extensive flooding, but also washed out a vulnerable section of stream banks along the main stem near Heilig School Road. Undercut banks collapsed, sandbars shifted, islands were reconfigured and silt and stones washed into the field beside the stream. To remedy this situation, the property owners have applied to DEP for a *Water Obstruction and Encroachment Permit* for proposed stream bank

restoration for the Pine Creek Watershed. The project consists of stream bank restoration along 1100 feet of the Pine Creek and its tributaries at the site.

addition to the bank stabilization effort, additional restoration activities will include aquatic habitat enhancement, improvement of sediment transport and establishing a riparian buffer through various plants and soil bioengineering practices. All of this work will be carried out by volunteers from Trout Unlimited, using Growing Greener Grant funding for plants and materials.
